Manhole Inspection Summary

Manhole # S29I__020MH

Insp Date: **9/4/08 1:06 PM**

Location Address: **Lemmon St.**

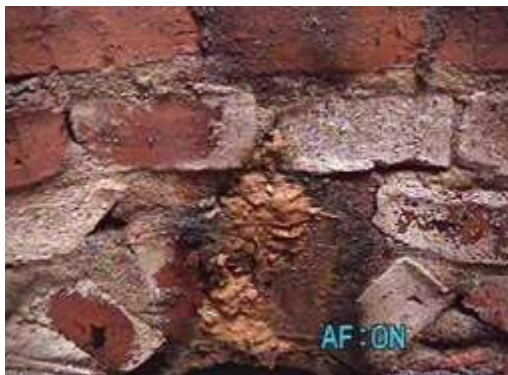
Defect 2

Infiltration: ☐ None ☐ Joint ☐ Cracks ☐ Mortar ☐ Roots ☒ **Wall**

barrel infiltration

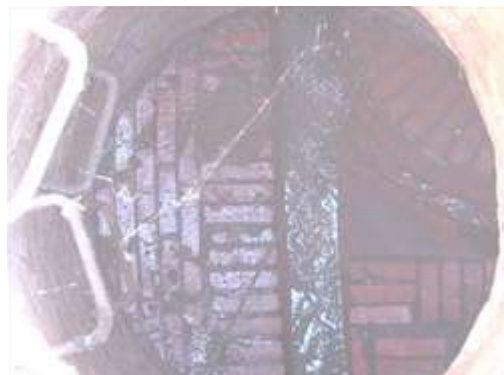
Defect 1

Steps Count: **5** Missing: **0** ☒ **Corroded**

corroded steps

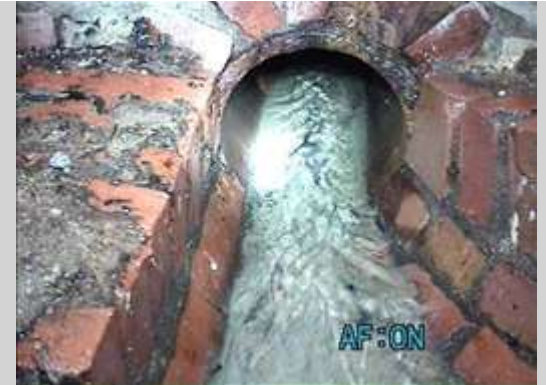
12 O'Clock Outflow

8 in. Circular Gravity Sewer
Pipe Out @ 12 O'Clock

Pipe Height: **9.6** (in.) Rod and Bar (Angled)
Pipe Material: **Clay** ☐ Pipe Lined
Invert Depth: **9.32** (ft.) Flow Characteristics: **Slow**
Deposits: ☒ None ☐ Mud ☐ Sludge ☐ Debris ☐ Grease
Silt Depth: **0** (in.) Deposits Extent:
Infiltration: **None** Pipe Seal Cond: **Sound**

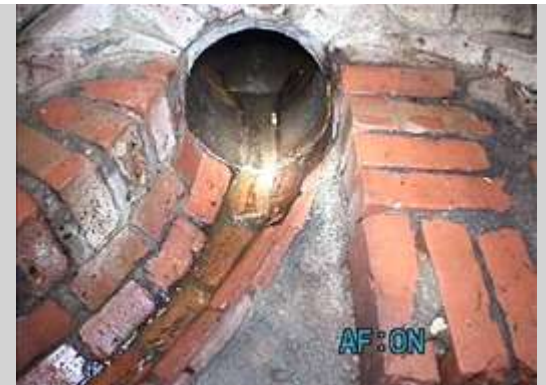
3 O'Clock Inflow

8 in. Circular Gravity Sewer
Pipe In @ 3 O'Clock

Pipe Height: **8.4** (in.) Rod and Bar (Angled)
Pipe Material: **Clay** ☐ Pipe Lined
Invert Depth: **8.81** (ft.) Flow Characteristics: **None**
Deposits: ☒ None ☐ Mud ☐ Sludge ☐ Debris ☐ Grease
Silt Depth: **0** (in.) Deposits Extent:
Infiltration: **None** Pipe Seal Cond: **Sound**

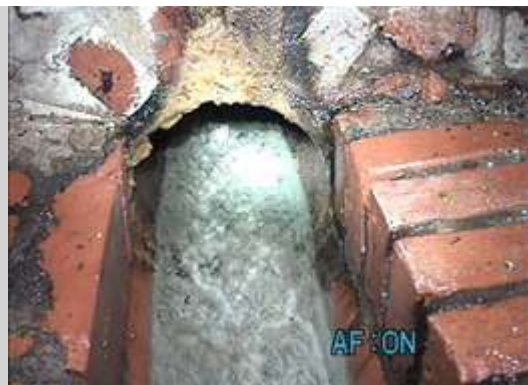
6 O'Clock Inflow

Pipe In @ 6 O'Clock

Pipe Height: **8.4** (in.) Rod and Bar (Angled)

Infiltration: **None** Pipe Seal Cond: **Sound**
